# Chapter 15 Mass Wasting

## 15.1 Factors That Control Slope Stability

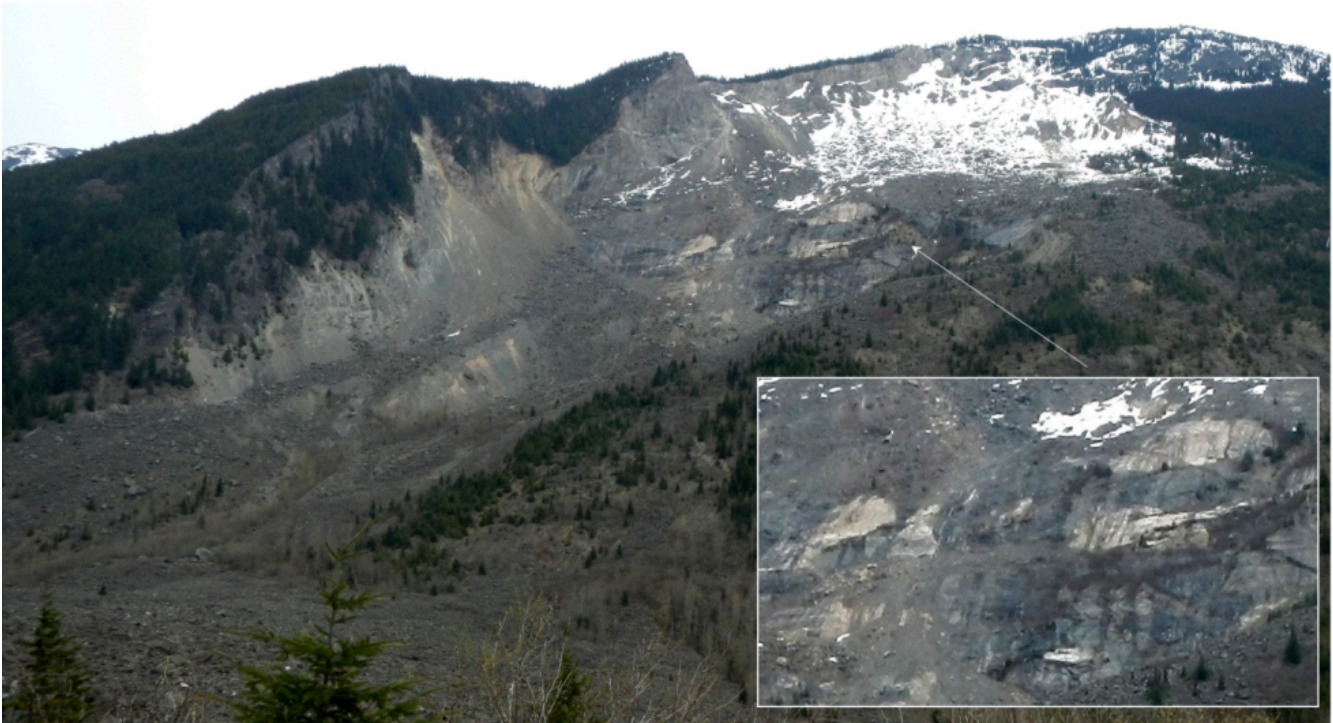
*Figure 15.0.1 The site of the 1965 Hope Slide as seen in 2014. The initial failure is thought to have taken place along the foliation planes and sill within the area shown in the inset.*

Early in the morning on January 9, 1965, 47 million cubic metres of rock broke away from the steep upper slopes of Johnson Peak (16 kilometres southeast of Hope) and roared 2,000 metres down the mountain, gouging out the contents of a small lake at the bottom, and continuing a few hundred metres up the other side (Figure 15.0.1). Four people, who had been stopped on the highway by a snow avalanche, were killed. Many more might have become victims, except that a Greyhound bus driver, en route to Vancouver, turned his bus around on seeing the avalanche. The rock failed along weakened foliation planes of the metamorphic rock on Johnson Peak, in an area that had been eroded into a steep slope by glacial ice. There is no evidence that it was triggered by any specific event, and there was no warning that it was about to happen. Even if there had been warning, nothing could have been done to prevent it. There are hundreds of similar situations throughout British Columbia.

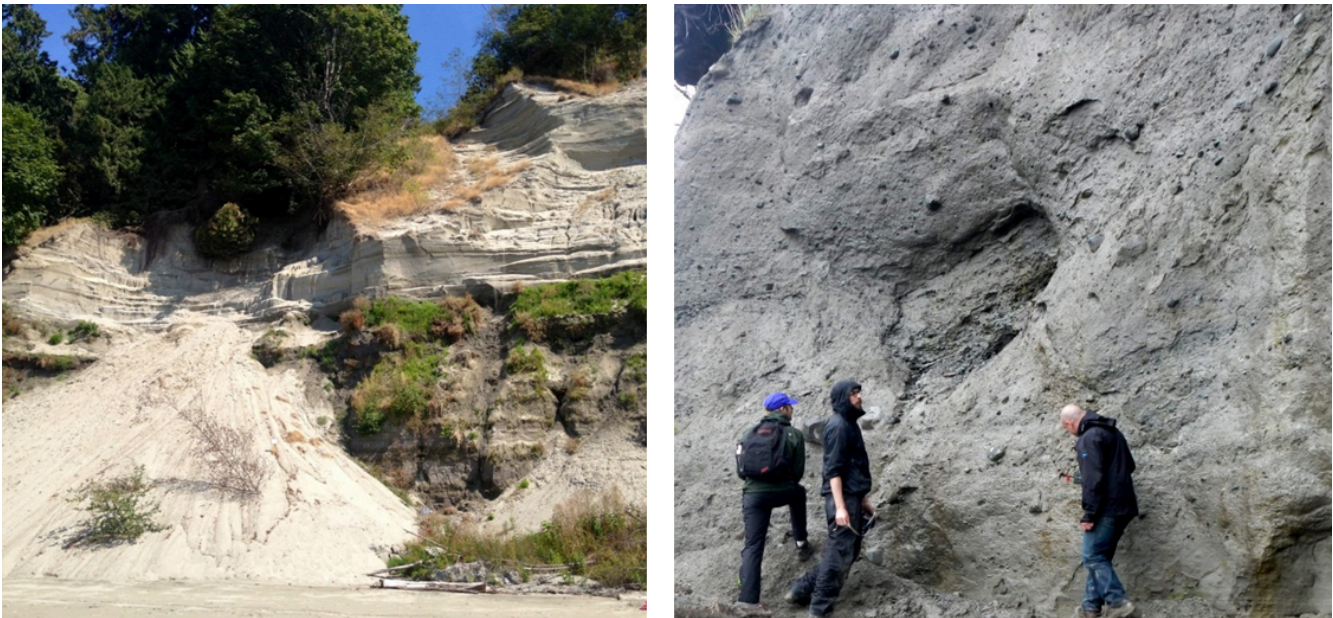
Figure 15.1.3 Left: Glacial outwash deposits at Point Grey, in Vancouver. The dark lower layer is made up of sand, silt, and clay. The light upper layer is well-sorted sand. Right: Glacial till on Quadra Island, B.C. The till is strong enough to have formed a near-vertical slope.

Unconsolidated sediments are generally weaker than sedimentary rocks because they are not cemented and, in most cases, have not been significantly compressed by overlying materials. This binding property of sediment is sometimes referred to as *cohesion*. Sand and silt tend to be particularly weak, clay is generally a little stronger, and sand mixed with clay can be stronger still. The deposits that make up the cliffs at Point Grey in Vancouver include sand, silt, and clay overlain by sand. As shown in Figure 15.1.3 (left) the finer deposits are relatively strong (they maintain a steep slope), while the overlying sand is relatively weak, and has a shallower slope that has recently failed. Glacial till—typically a mixture of clay, silt, sand, gravel, and larger clasts—forms and is compressed beneath tens to thousands of metres of glacial ice so it can be as strong as some sedimentary rock (Figure 15.1.3, right).

In some cases, a *decrease* in water content can lead to failure. This is most common with clean sand deposits (e.g., the upper layer in Figure 15.1.3 (left)), which lose strength when there is no water to hold the grains together.

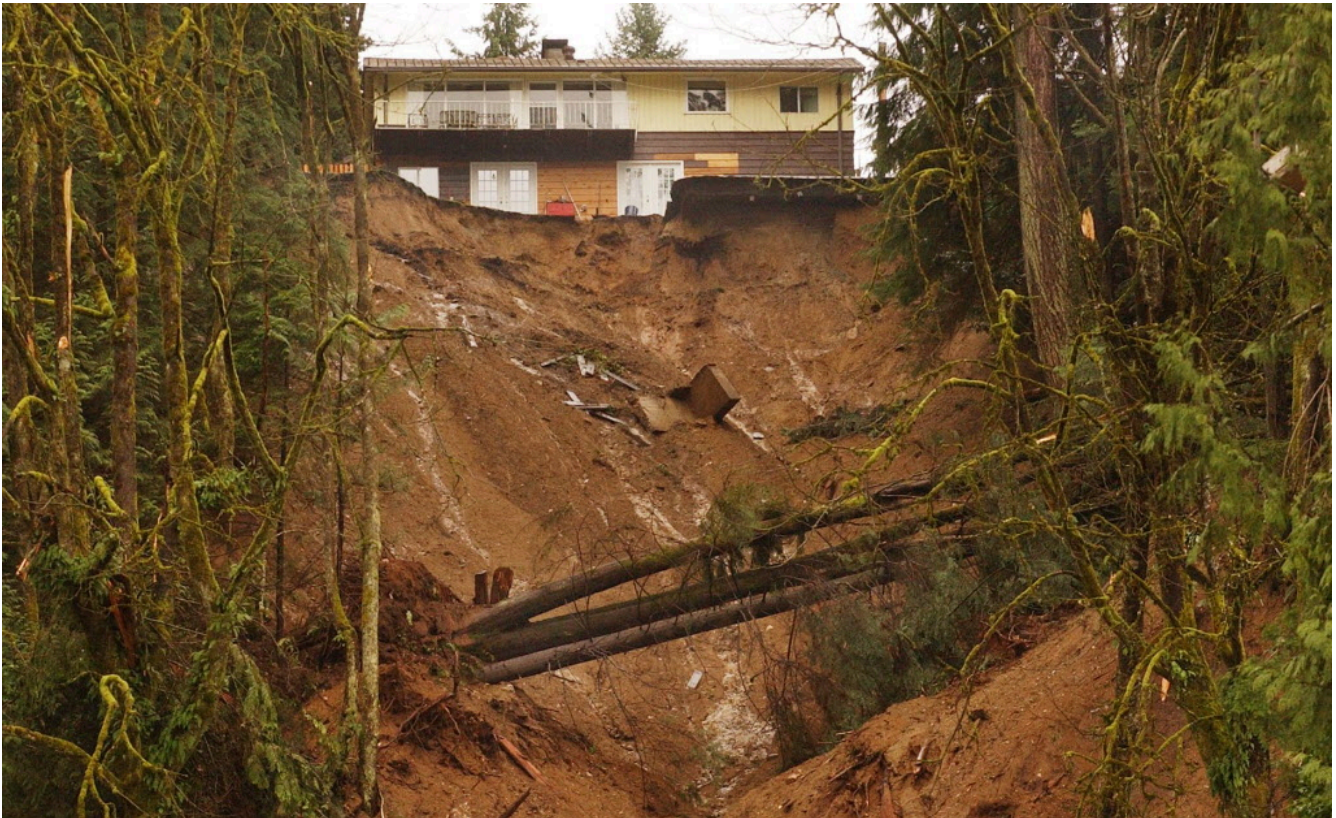
*Figure 15.1.6 The debris flow in the Riverside Drive area of North Vancouver in January, 2005 happened during a rainy period, but was likely triggered by excess runoff related to the roads at the top of this slope and by landscape features, including a pool, in the area surrounding the house visible here.*

An increase in water content is the most common mass-wasting trigger. This can result from rapid melting of snow or ice, heavy rain, or some type of event that changes the pattern of water flow on the surface. Rapid melting can be caused by a dramatic increase in temperature (e.g., in spring or early summer) or by a volcanic eruption. Heavy rains are typically related to major storms. Changes in water flow patterns can be caused by earthquakes, previous slope failures that dam up streams, or human structures that interfere with runoff (e.g., buildings, roads, or parking lots). An example of this is the deadly 2005 debris flow in North Vancouver (Figure 15.1.6). The 2005 failure took place in an area that had failed previously, and a report written in 1980 recommended that the municipal authorities and residents take steps to address surface and slope drainage issues. Little was done to improve the situation.

Delaying mass wasting is a worthy endeavour, of course, because during the time that the measures are still effective they can save lives and reduce damage to property and infrastructure. The other side of the coin is that we must be careful to avoid activities that could make mass wasting more likely. One of the most common anthropogenic causes of mass wasting is road construction, and this applies both to remote gravel roads built for forestry and mining and large urban and regional highways. Road construction is a potential problem for two reasons. First, creating a flat road surface on a slope inevitably involves creating a cut bank that is steeper than the original slope. This might also involve creating a filled bank that is both steeper and weaker than the original slope (Figure 15.2.12). Second, roadways typically cut across natural drainage features, and unless great care is taken to reroute the runoff water and prevent it from forming concentrated flows, oversaturating fill of materials can result. A specific example of the contribution of construction-related impeded drainage to slope instability was shown earlier in Figure 15.1.6.

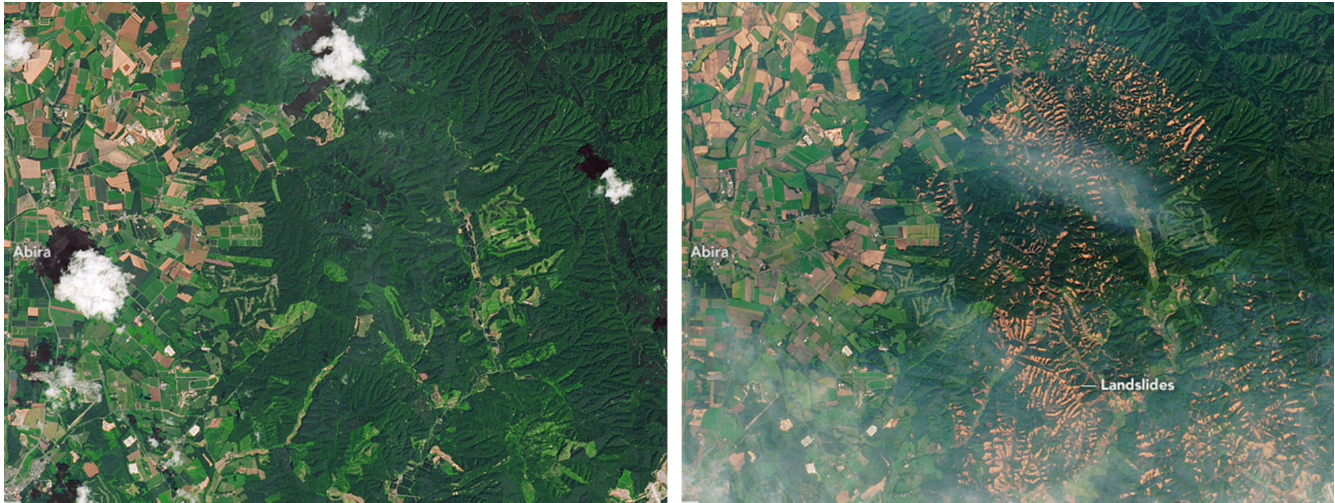
Figure 15.1.7 Slope failures in the Sapporo area of Japan following a typhoon (Sept. 4th, 2018) and earthquake (Sept. 6th, 2018) (Before and after Landsat 8 images: left: July 2017, right: September 2018).

in the Sapporo area of Hokkaido, Japan in September 2018, as shown on Figure 15.1.7. The area was drenched with rain from tropical storm Jebi on September 4th. On September 6th it was shaken by a M6.6 earthquake which triggered debris flows in the water-saturated volcanic materials on steep slopes. There were 41 deaths related to the slope failures.

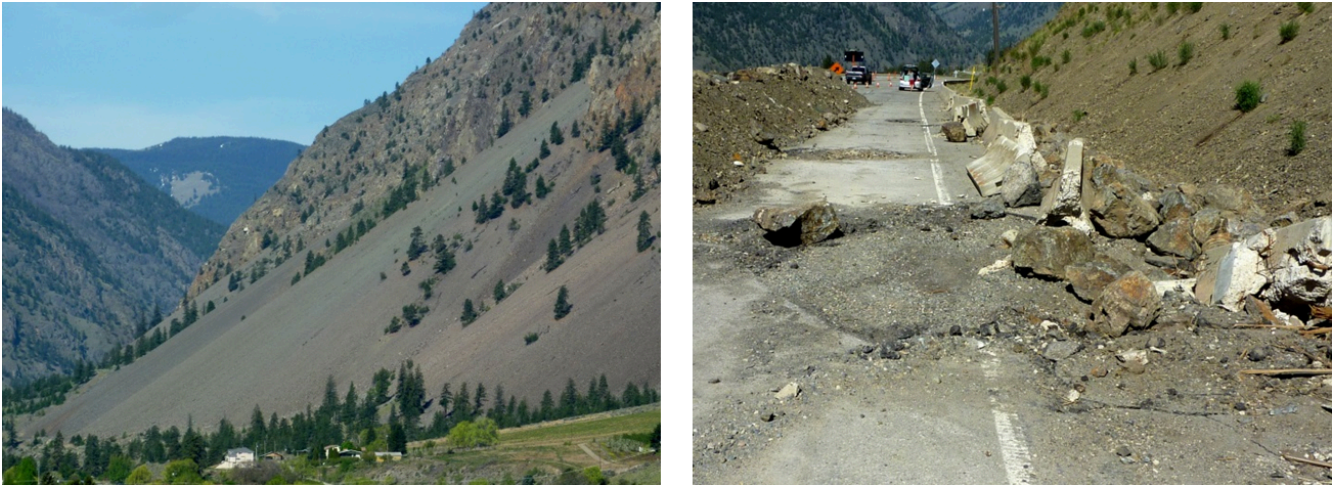
Figure 15.2.2 Left: A talus slope near Keremeos, B.C., formed by rock fall from the cliffs above. Right: The results of a rock fall onto a highway west of Keremeos in December 2014.

A typical talus slope, near Keremeos in southern B.C., is shown in Figure 15.2.2. In December 2014, a large block of rock split away from a cliff in this same area. It broke into smaller pieces that tumbled down the slope and crashed into the road, smashing the concrete barriers and gouging out large parts of the pavement. Luckily no one was hurt.

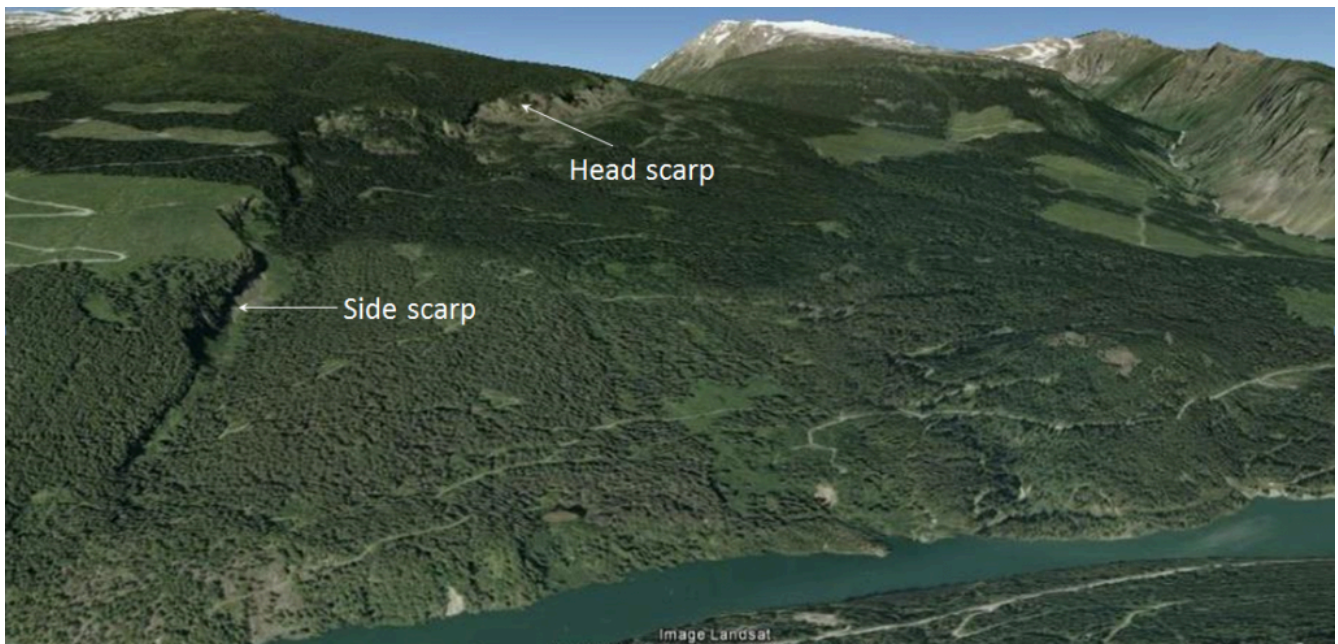
Figure 15.2.3 The Downie Slide, a sackung, on the shore of the Revelstoke Reservoir (above the Revelstoke Dam). The head scarp is visible at the top and a side-scarp along the left side.

A rock slide is the sliding motion of rock along a sloping surface. In most cases, the movement is parallel to a fracture, bedding, or metamorphic foliation plane, and it can range from very slow to moderately fast. The word **sackung** describes the very slow motion of a block of rock (millimetres per year to centimetres per year) on a slope. A good example is the Downie Slide north of Revelstoke, B.C., which is shown in Figure 15.2.3. In this case, a massive body of rock is very slowly sliding down a steep slope along a plane of weakness that is approximately parallel to the slope. The Downie Slide, which was first recognized in the 1950s, prior to the construction of the Revelstoke Dam in the late 1970s, was moving very slowly at the time (a few centimetres per year). Geological engineers were concerned that the presence of water in the reservoir (visible in Figure 15.2.3) could further weaken the plane of failure, leading to an acceleration of the motion. The result would have been a catastrophic failure into the reservoir that would have sent a wall of water over the dam and into the community of Revelstoke. During the construction of the dam they tunneled into the rock at the base of the slide and drilled hundreds of drainage holes upward into the plane of failure. This allowed water to drain out so that the pressure was reduced, which reduced the rate of movement of the sliding block. BC Hydro monitors this site continuously; the slide block is currently moving more slowly than it was prior to the construction of the dam.

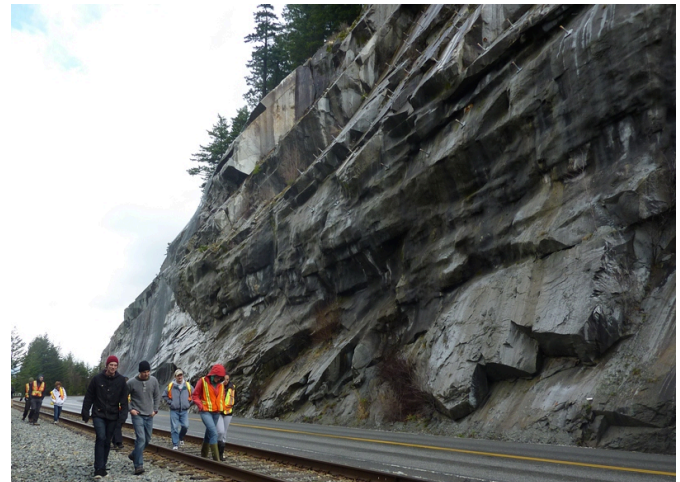
Figure 15.2.4 Site of the 2008 rock slide at Porteau Cove. Notice the prominent fracture set parallel to the surface of the slope. The slope has been stabilized with rock bolts (visible near to the top of the photo) and holes have been drilled into the rock to improve drainage (one is visible in the lower right). Risk to passing vehicles from rock fall has been reduced by hanging mesh curtains (background).

In the summer of 2008, a large block of rock slid rapidly from a steep slope above Highway 99 near Porteau Cove (between Horseshoe Bay and Squamish). The block slammed into the highway and adjacent railway and broke into many pieces. The highway was closed for several days, and the slope was subsequently stabilized with rock bolts and drainage holes. As shown in Figure 15.2.4, the rock is fractured parallel to the slope, and this almost certainly contributed to the failure. However, it is not actually known what triggered this event as the weather was dry and warm during the preceding weeks, and there was no significant earthquake in the region.

It is comforting to think that we can prevent some effects of mass wasting by mechanical means, such as the rock bolts in the road cut at Porteau Cove (Figure 15.2.4), or the drill holes used to drain water out of a slope, as was done at the Downie Slide (Figure 15.2.3), or the building of physical barriers, such as retaining walls. What we have to remember is that the works of humans are mostly insignificant compared to the works of nature. The rock bolts in the road cut at Porteau Cove will slowly start to corrode after a few years, and within a few decades, many of them will begin to lose their strength. Unless they are replaced, they will no longer support that slope. Likewise, drainage holes at the Downie Slide will eventually become plugged with sediment and chemical precipitates, and unless they are periodically unplugged, their effectiveness will decrease. Eventually, unless new holes are drilled, the drainage will be so compromised that the slide will start to move again. This is why careful long-term slope monitoring by geological and geotechnical engineers is important at these sites. The point here is that our efforts to “prevent” mass wasting are only as good as our resolve to maintain those preventive measures.

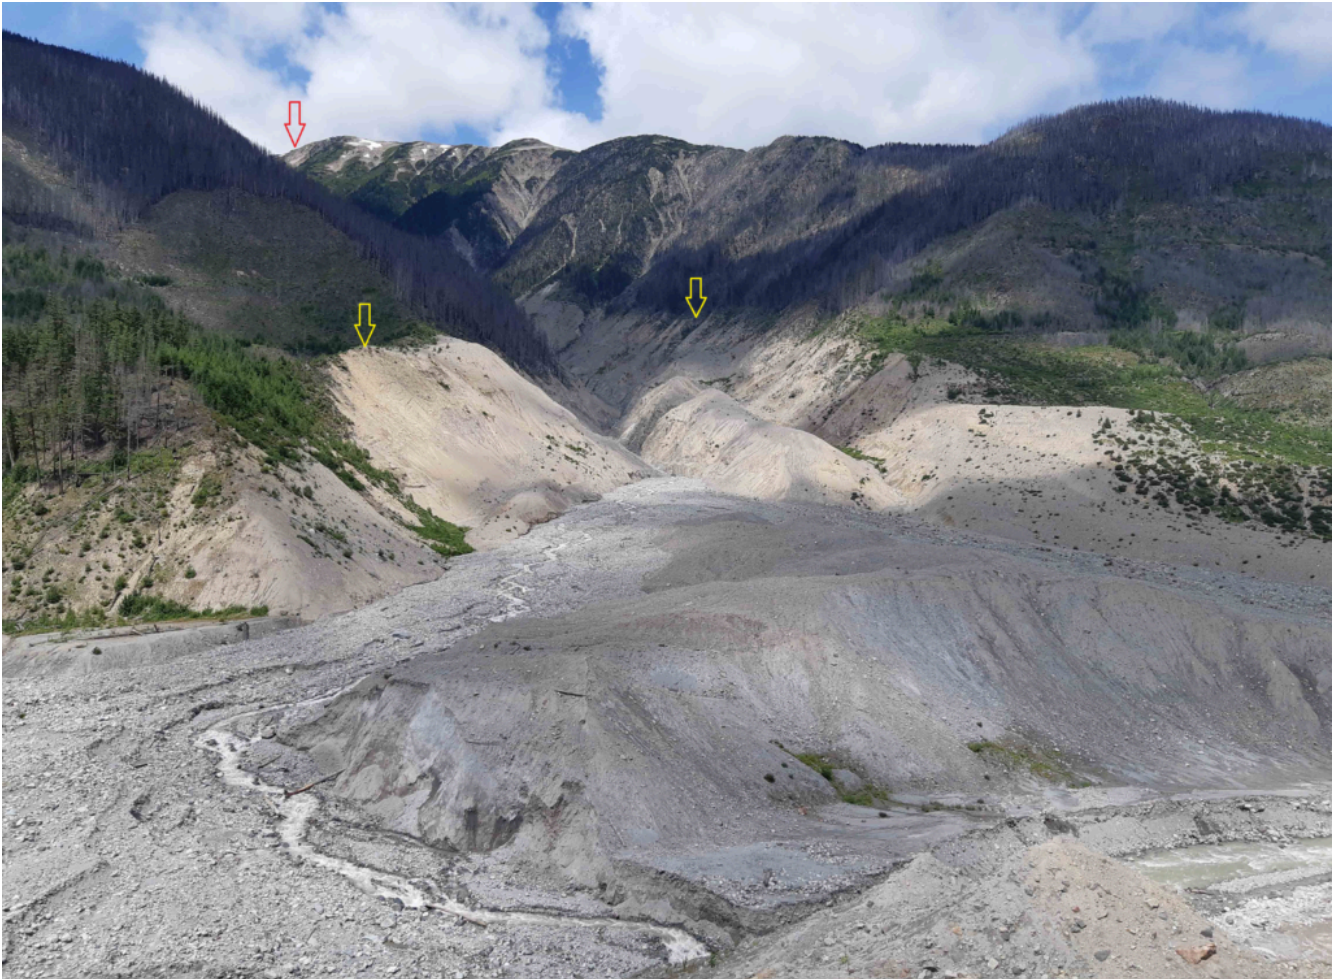
*Figure 15.2.5 The August 2010 Mount Meager rock avalanche, showing where the slide originated (red arrow, 4 km upstream) and its path down a steep narrow valley. The yellow arrows show how far up the valley the avalanche extended.*

If a rock slides and then starts moving quickly (metres per second), the rock is likely to break into many small pieces, and at that point it turns into a **rock avalanche**, in which the large and small fragments of rock move in a fluid manner supported by a cushion of air within and beneath the moving mass. The 1965 Hope Slide (Figure 15.0.1) was a rock avalanche, as was the famous 1903 Frank Slide in southwestern Alberta. The 2010 slide at Mount Meager (west of Lillooet) was also a rock avalanche, and rivals the Hope Slide as the largest slope failure in Canada during historical times (Figure 15.2.5).

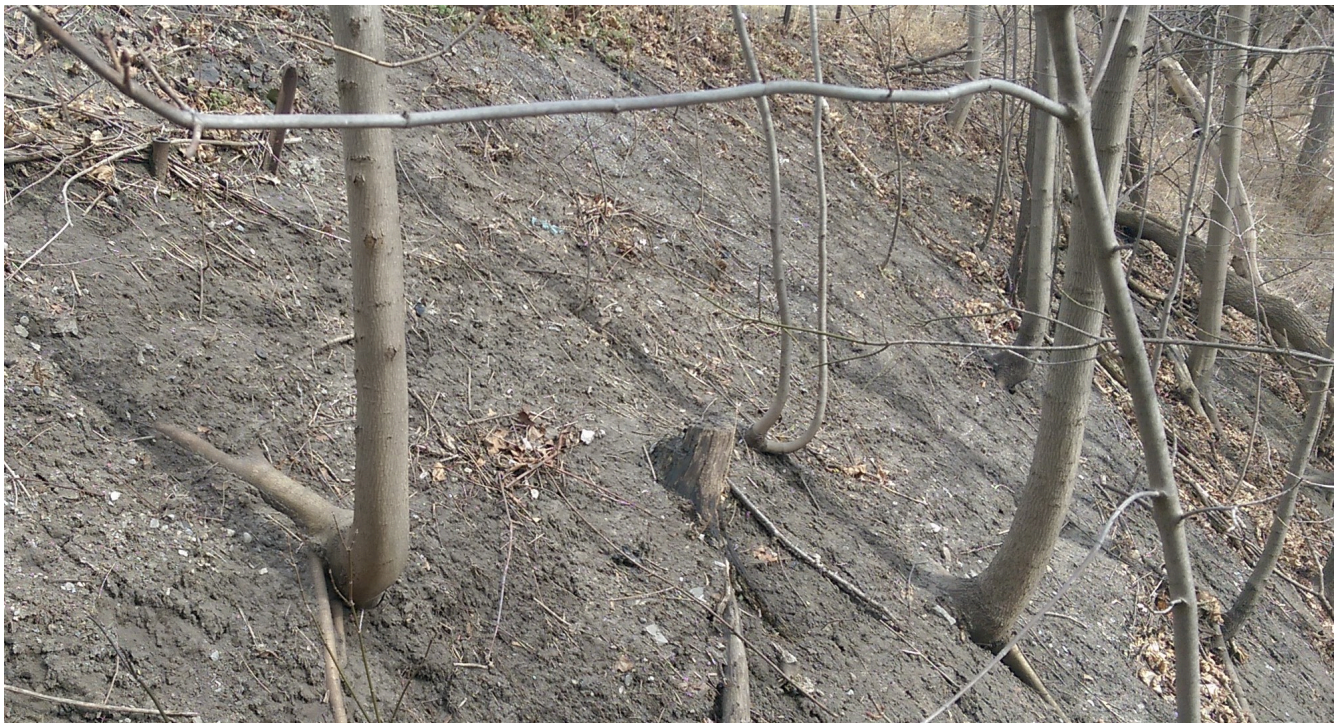
Figure 15.2.7 Pistol-butt shaped trees on a slope that is experiencing creep

Creep is most noticeable on moderate-to-steep slopes where trees, fence posts, or grave markers are consistently leaning in a downhill direction. In the case of trees, they try to correct their lean by growing upright, and this leads to a curved lower trunk known as a “pistol butt.” An example is shown on Figure 15.2.7.

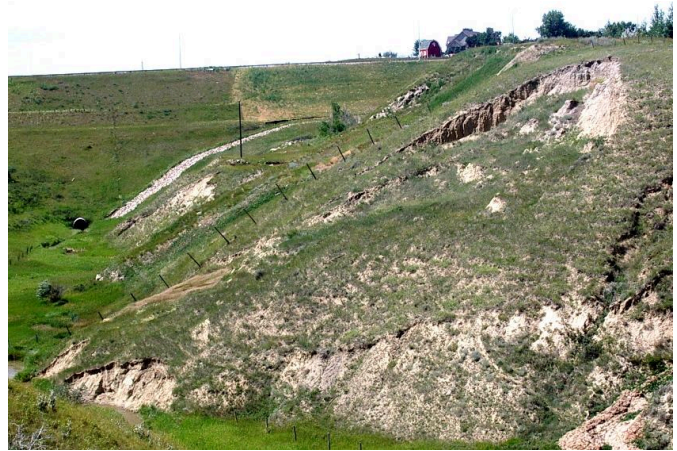
Figure 15.2.9 A slump along the banks of a small coulee near Lethbridge, Alberta. The main head-scarp is clearly visible at the top, and a second smaller one is visible about one-quarter of the way down. The toe of the slump is being eroded by the seasonal stream that created the coulee.

An example of a slump in the Lethbridge area of Alberta is shown in Figure 15.2.9. This feature has likely been active for many decades, and moves a little more whenever there are heavy spring rains and significant snowmelt runoff. The toe of the slump is failing because it has been eroded by the small stream at the bottom.

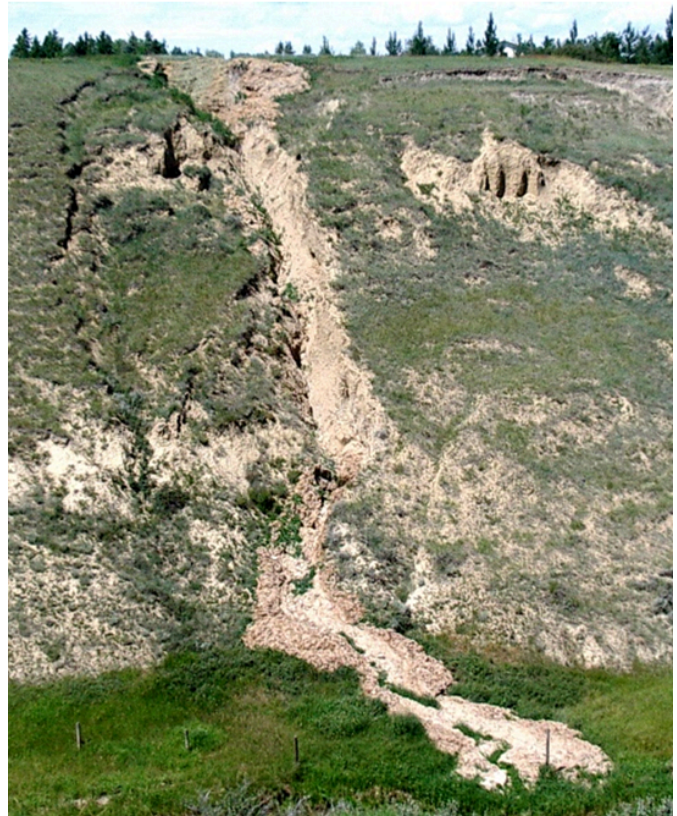
Figure 15.2.10 A slump (left) and an associated mudflow (centre) at the same location as Figure 15.2.9, near Lethbridge, Alberta.

As you saw in Exercise 15.1, when a mass of sediment becomes completely saturated with water, the mass loses strength, to the extent that the grains are pushed apart, and it will flow, even on a gentle slope. This can happen during rapid spring snowmelt or heavy rains, and is also relatively common during volcanic eruptions because of the rapid melting of snow and ice. (A mudflow or debris flow on a volcano or during a volcanic eruption is a *lahar*.) If the material involved is primarily sand-sized or smaller, it is known as a mudflow, such as the one shown in Figure 15.2.10.

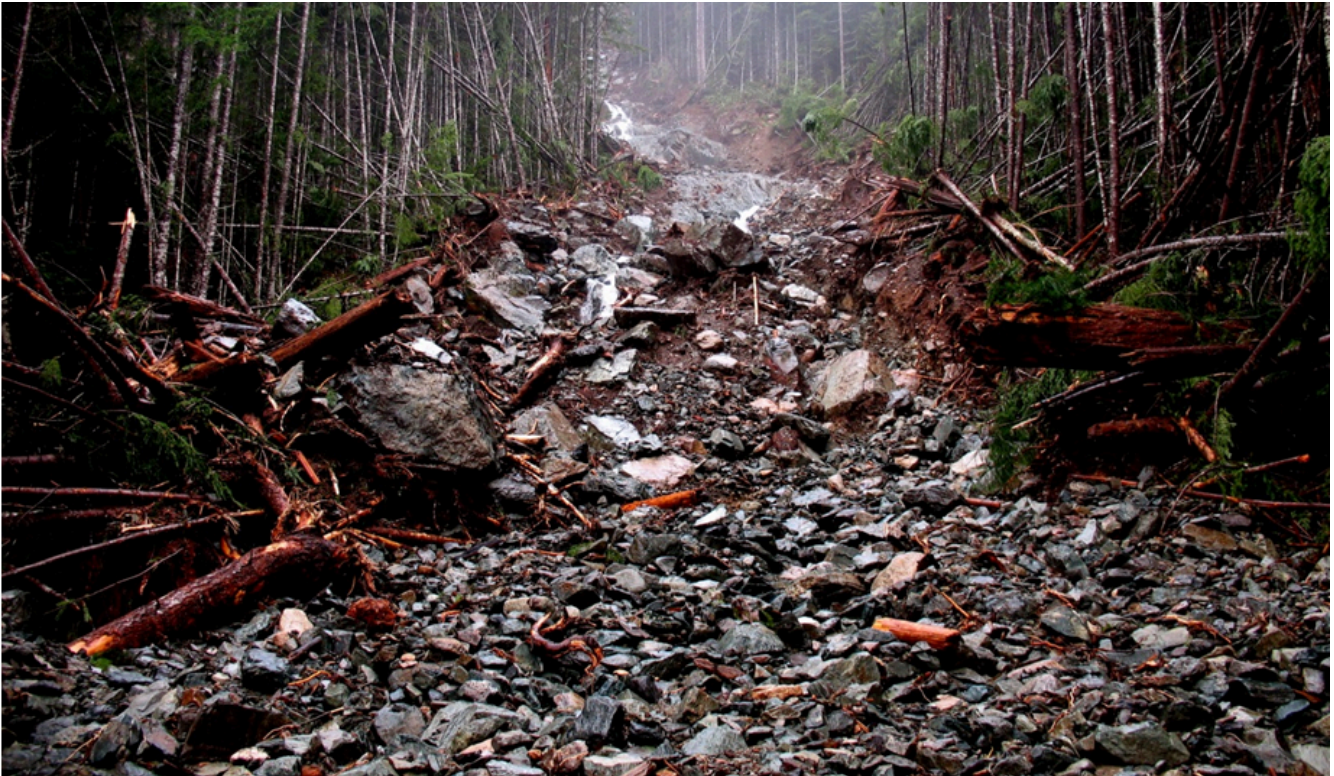
Figure 15.2.11 The lower part of debris flow within a steep stream channel near Buttle Lake, B.C., in November 2006.

If the material involved is gravel sized or larger, it is known as a debris flow. Because it takes more gravitational energy to move larger particles, a debris flow typically forms in an area with steeper slopes and more water than does a mudflow. In many cases, a debris flow takes place within a steep stream channel, and is triggered by the collapse of bank material into the stream. This creates a temporary dam, and then a major flow of water and debris when the dam breaks. This is the situation that led to the fatal debris flow at Johnsons Landing, B.C., in 2012. A typical west-coast debris flow is shown in Figure 15.2.11. This event took place in November 2006 in response to very heavy rainfall. There was enough energy to move large boulders and to knock over large trees.

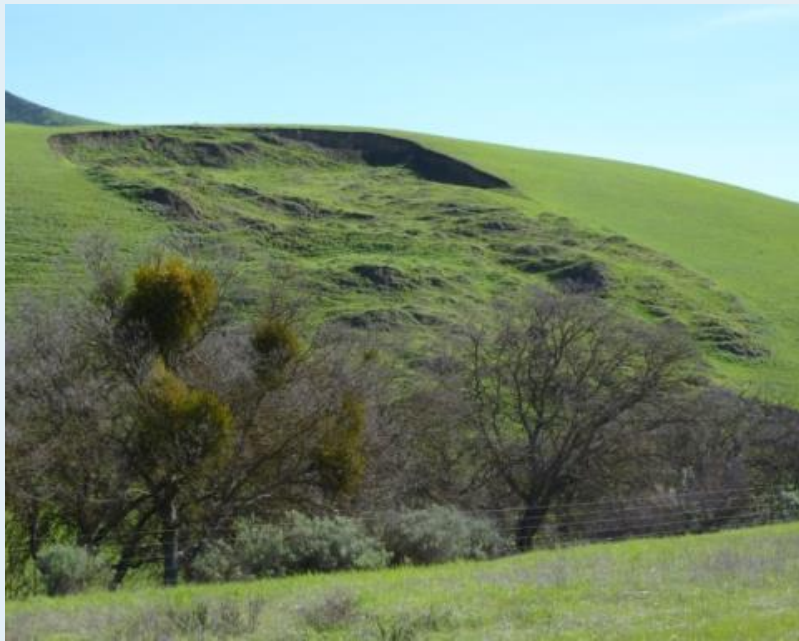
Figure 15.2.12a

These four photos show some of the different types of slope failures described above. Try to identify each types and provide some criteria to support your choice.

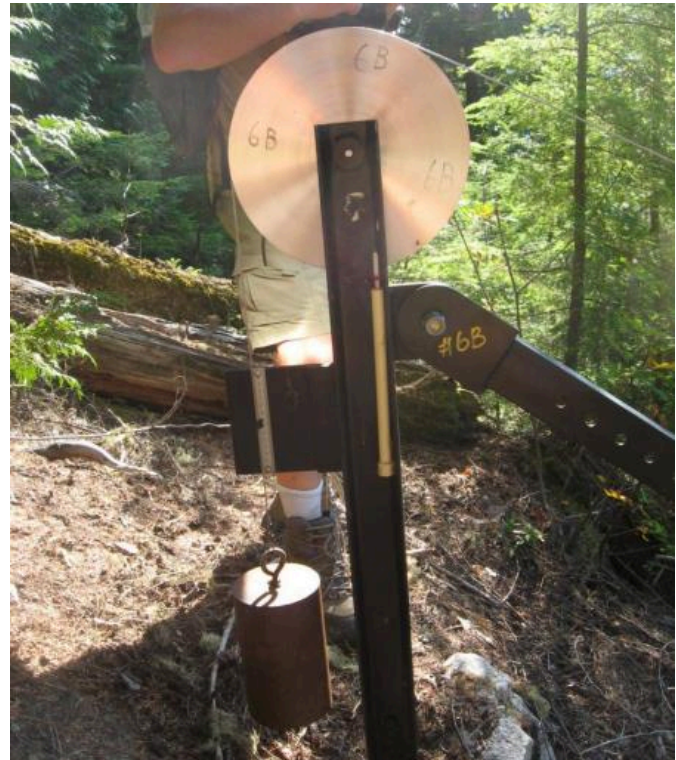
*Figure 15.3.3 Part of a motion-monitoring device at the Checkerboard Slide near Revelstoke, B.C. The lower end of the cable is attached to a block of rock that is unstable. Any incremental motion of that block will move the cable, which will be detectable on this device.*

In some areas, it is necessary to establish warning systems so that we know if conditions have changed at a known slide area, or if a rapid failure, such as a debris flow, is actually on its way downslope. The Downie Slide above the Revelstoke Reservoir is monitored 24/7 with a range of devices, such as inclinometers (slope-change detectors), bore-hole motion sensors, and GPS survey instruments. A simple mechanical device for monitoring the nearby Checkerboard Slide (which is also above the Revelstoke Reservoir) is shown in Figure 15.3.3. Both of these are very slow-moving rock slides, but it's critically important to be able to detect changes in their rates of motion because at both of these locations a rapid failure would result in large bodies of rock plunging into the reservoir and sending a wall of water over the Revelstoke Dam, potentially destroying the nearby town of Revelstoke.

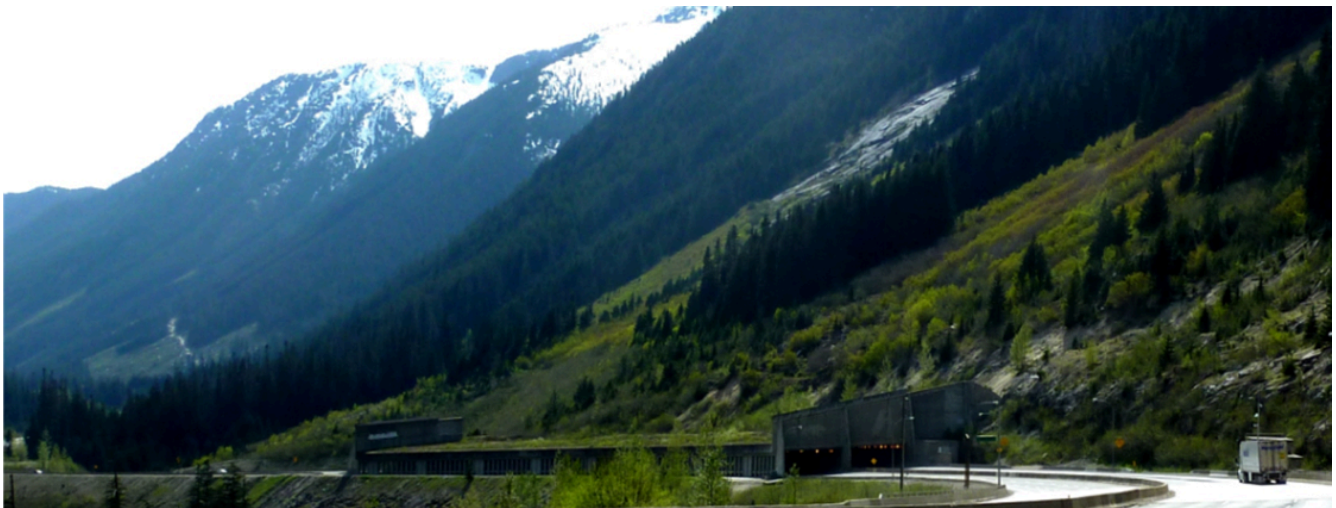
Figure 15.3.5 A snow avalanche shelter on the Coquihalla Highway. The expected path of the avalanche is the steep un-treed slope above.

In situations where we can't predict, prevent, or delay mass-wasting, some effective measures can be taken to minimize the associated risk. For example, many highways in B.C. and western Alberta have avalanche shelters like that shown in Figure 15.3.5. In some parts of the world, similar features have been built to protect infrastructure from other types of mass wasting.

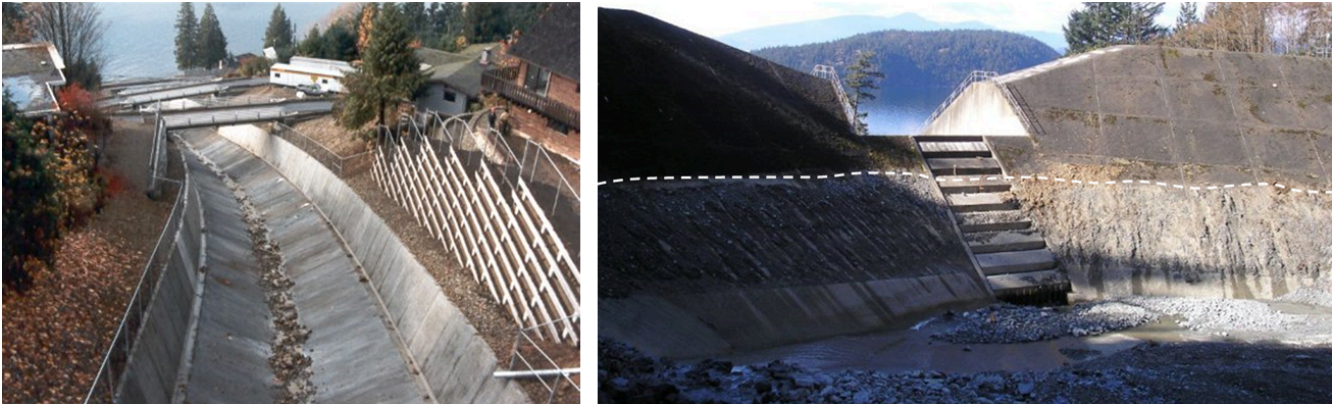
*Figure 15.3.6 Two strategies for mitigating debris flows on the Sea-to-Sky Highway. Left: A concrete-lined channel on Alberta Creek allows debris to flow quickly through to the ocean. Right: A debris-flow catchment basin on Charles Creek. In 2010, a debris flow filled the basin to the level of the dotted white line.*

Debris flows are inevitable, unpreventable, and unpredictable in many parts of B.C., but nowhere more so than along the Sea-to-Sky Highway between Horseshoe Bay and Squamish. The results have been deadly and expensive many times in the past. It would be very expensive to develop a new route in this region, so provincial authorities have taken steps to protect residents and traffic on the highway and the railway. Debris-flow defensive structures have been constructed in several drainage basins, as shown in Figure 15.3.6. One strategy is to allow the debris to flow quickly through to the ocean along a smooth channel. Another is to capture the debris within a constructed basin that allows the excess water to continue through, but catches the debris materials.
